HALL PRIMARY SCHOOL MASTERPLAN

Prepared by

Eric Martin and Associates

DRAFT
ISSUE 1
10J4
21 January 2011

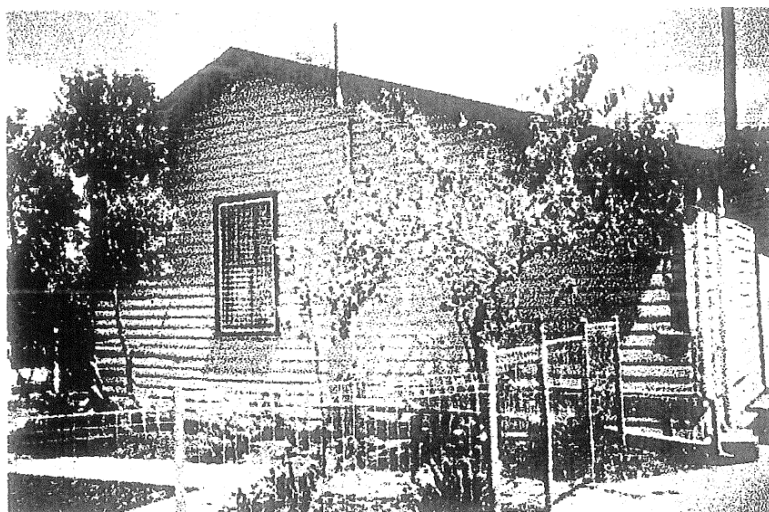
Hall Public School
PF.2000 photograph

The original school building is a single storey horizontal shiplap weatherboard building, painted a strong cream with brown trims, with a corrugated gable roof. The front [north] elevation of this building, which is the gable end, features a brick chimney and timber door, with a timber supported hood over. A ventilation vent cover has been removed and it appears that rabbits and rodents are entering the under-floor space.

The east elevation features a tall doorway. The doorway is composed of double swing doors and highlight window above. The doors are constructed of vertical timber boarding. The highlight window is composed of three windows, with security mesh fixed to the inside. There are plumbing fixtures attached to the external wall. The south elevation features a single double hung timber window, that is aligned with the apex of the gable. The window is composed of six panes to the top light and the bottom light is divided equally in half. Most of the original fabric and features of the original school remain intact and should be conserved. However the later additional buildings have affected the visual setting of the building. There are two plaques fixed to the external wall of the building. A

The building is in sound condition, being regularly maintained by Mr Laurie Copping, a founder of the Museum and ex-principal. The peace tree is leaning away from the adjacent building but is stable and in good condition. Junipers are a very long-lived species.

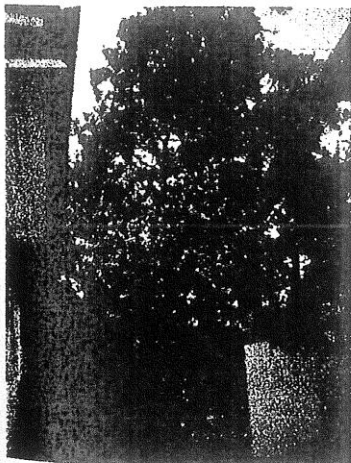
Peace Tree
Note the extreme lean, caused by site conditions.
PF 2000 photograph
